KANE STREET SYNAGOGUE

Update: Kane Street Synagogue Restoration Project – February 2016

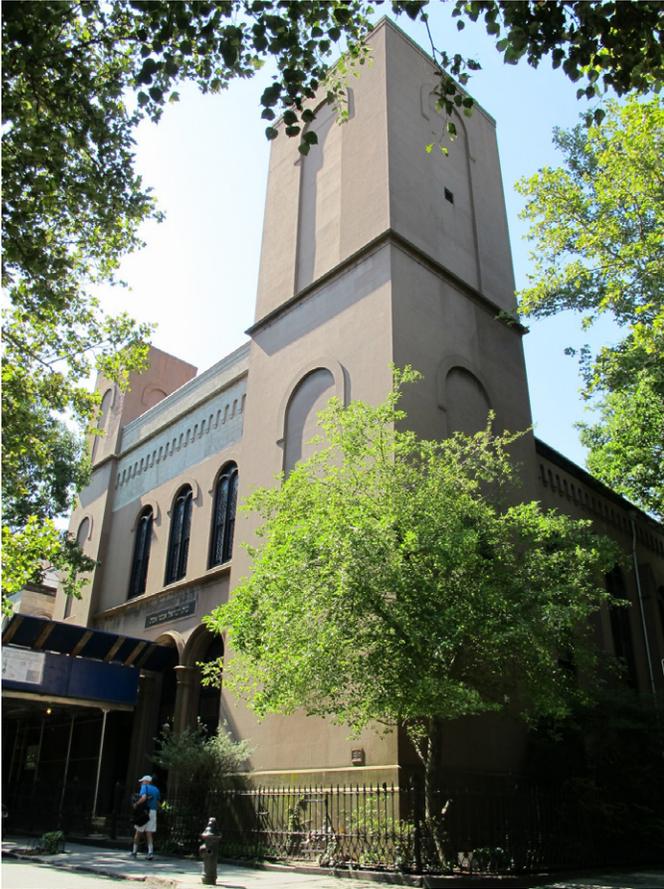
Photo N° 1 (Existing condition)

Note suggestions of early trim at windows and band courses.

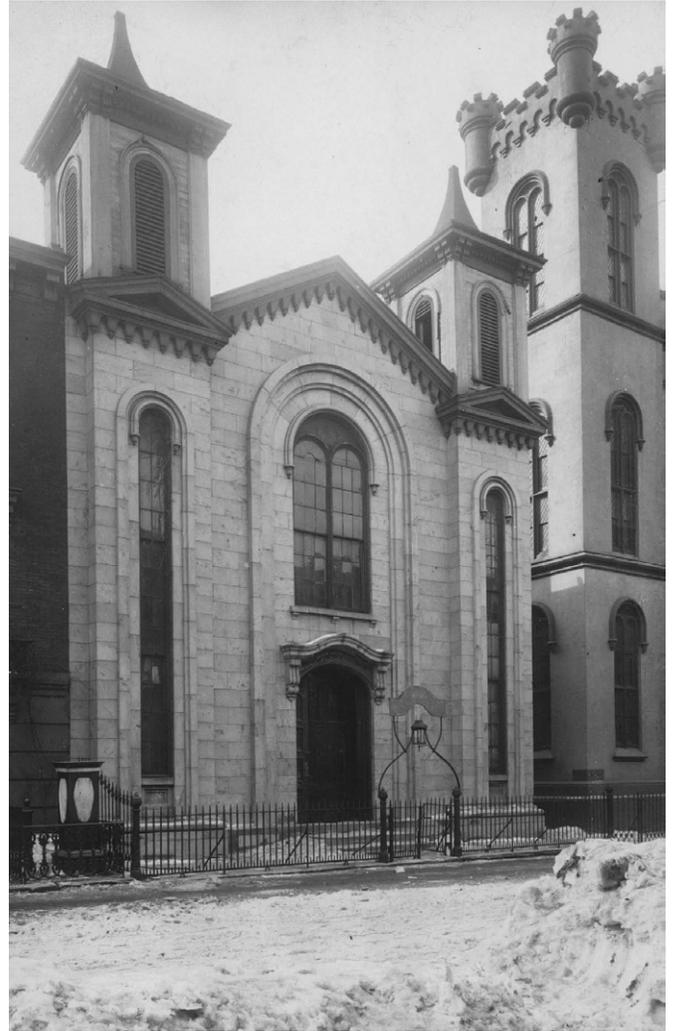
Photo No. 2 (c1905-1930)

At far right, note east tower brownstone trim at window arches, band courses, parapet and bartizans. Note contrast between light colored stucco and brownstone trim.

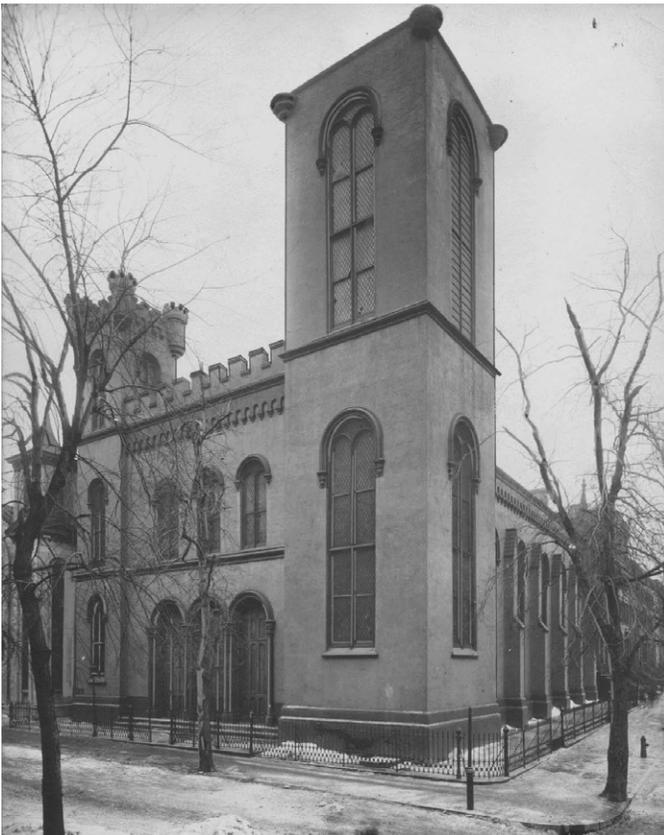
Photo No. 3 (c1905)

Note crenellated parapet at east tower and center bay, and diamond-pane windows. It is likely that the top of the west tower (right) was originally decorated much like that on the east (left).
